Manhole Inspection Summary

Manhole # S19M__047MH

Location Address: **2117 christian st** Cross Street: **s smallwood st**

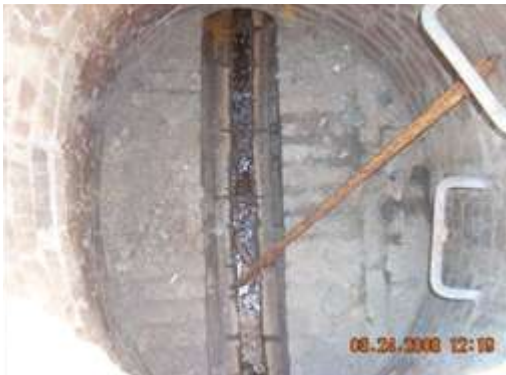
misc

channel debris

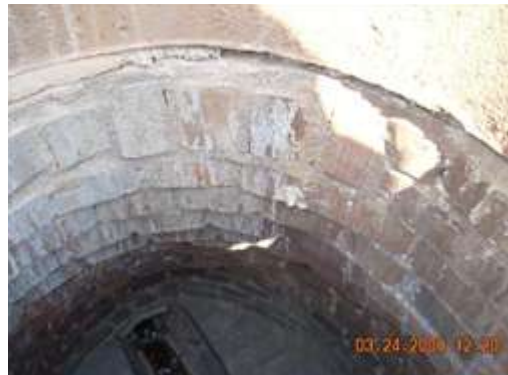
Defect 1

Condition: ☐ Sound ☒ **Cracked** ☐ Root Intrusion ☐ Loose Brick ☐ Deteriorated

Infiltration: ☐ None ☒ **Joint** ☐ Cracks ☐ Mortar ☐ Roots ☐ Wall

cracks and infiltration @ chimney joint

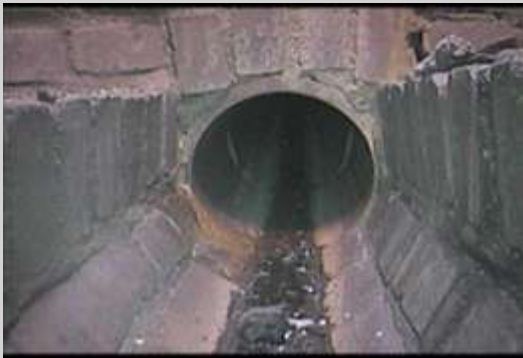
12 O'Clock Outflow

8 in. Circular Gravity Sewer
Pipe Out @ 12 O'Clock

Pipe Height: **7.2** (in.) Rod and Bar (Angled)
Pipe Material: **Clay** ☐ Pipe Lined
Invert Depth: **5.68** (ft.) Flow Characteristics: **Slow**
Deposits: ☒ None ☐ Mud ☐ Sludge ☐ Debris ☐ Grease
Silt Depth: **0** (in.) Deposits Extent:
Infiltration: **None** Pipe Seal Cond: **Sound**

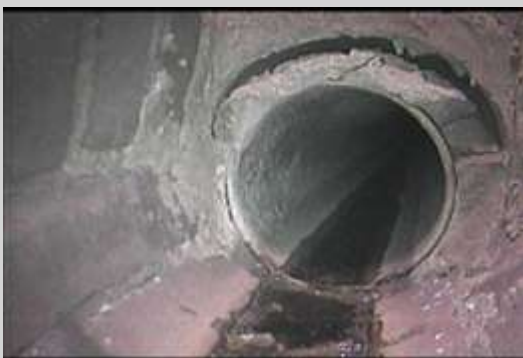
6 O'Clock Inflow

6 in. Circular Gravity Sewer
Pipe In @ 6 O'Clock

Pipe Height: **6** (in.) Rod and Bar (Angled)
Pipe Material: **Clay** ☐ Pipe Lined
Invert Depth: **5.20** (ft.) Flow Characteristics: **Slow**
Deposits: ☒ None ☐ Mud ☐ Sludge ☐ Debris ☐ Grease
Silt Depth: **0** (in.) Deposits Extent:
Infiltration: **None** Pipe Seal Cond: **Broken**

Connects To: **House connection / Service line**
